The XXIV European Synchrotron Light Source Workshop

MAXIV vacuum system, from design to operation

Eshraq Al-Dmour,
MAX IV laboratory

On behalf of the vacuum team
30th Nov. 2016

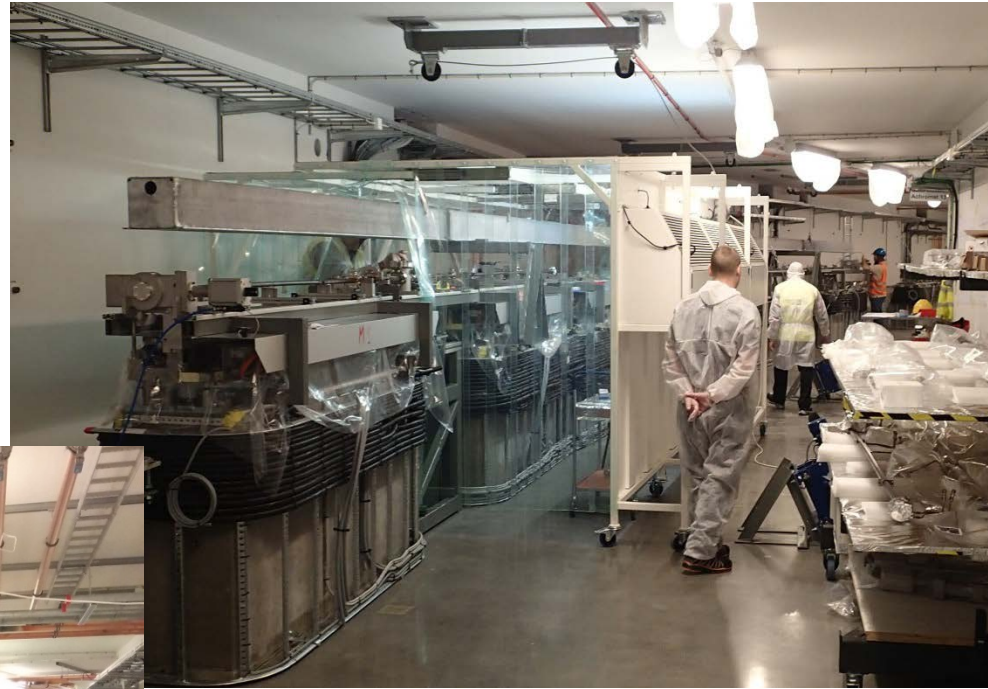
Installation procedure

- Assembly in-situ (above magnets),
- Pump down and testing,
- Lifting,
- Bake out (1 day), activation (1 day),

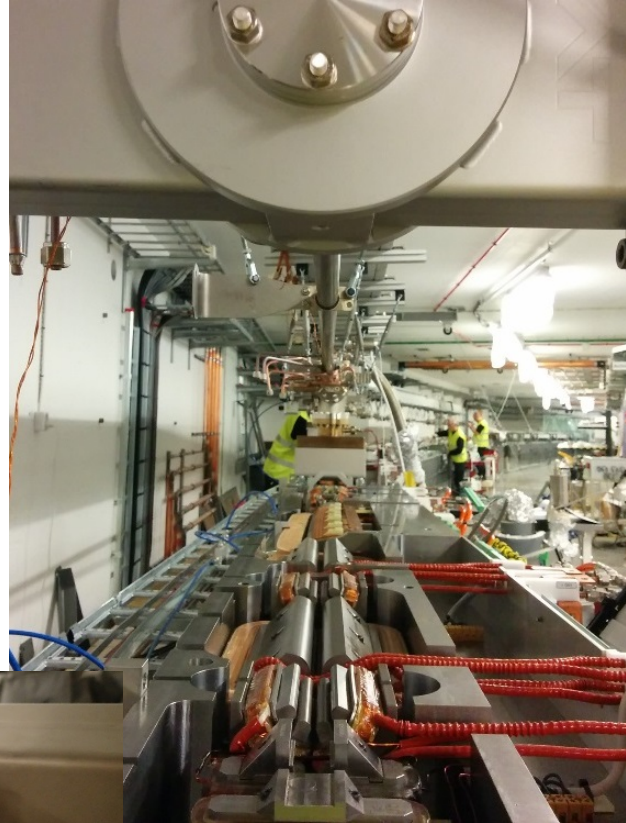
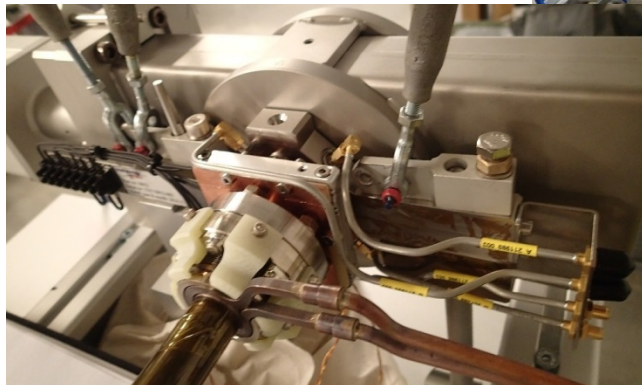
Installation procedure

- Lowering to the bottom magnet half,
- Installation of final equipment (supports, BPM cables),
- Lowering to magnet block.

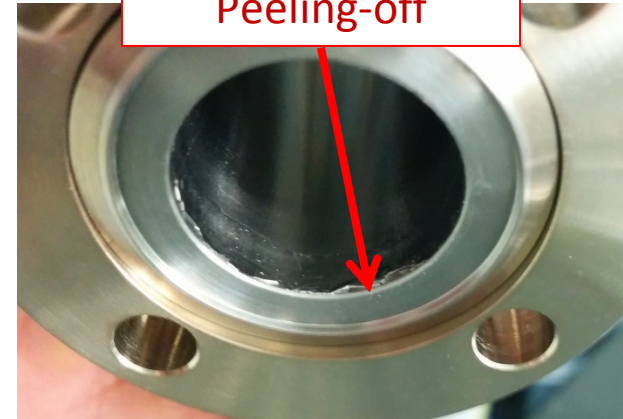
Peeling-off at the edge of stainless VC. Chamber not approved for installation.

Peeling-off

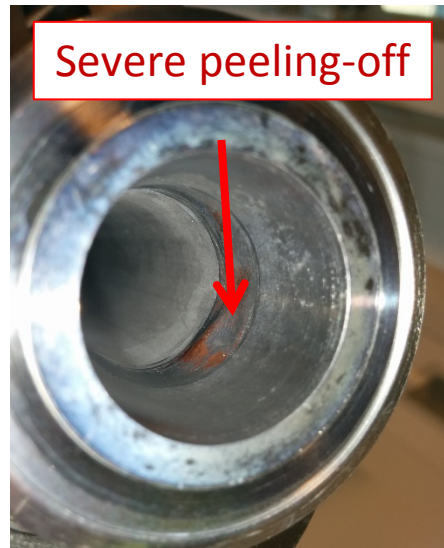
Severe peeling-off

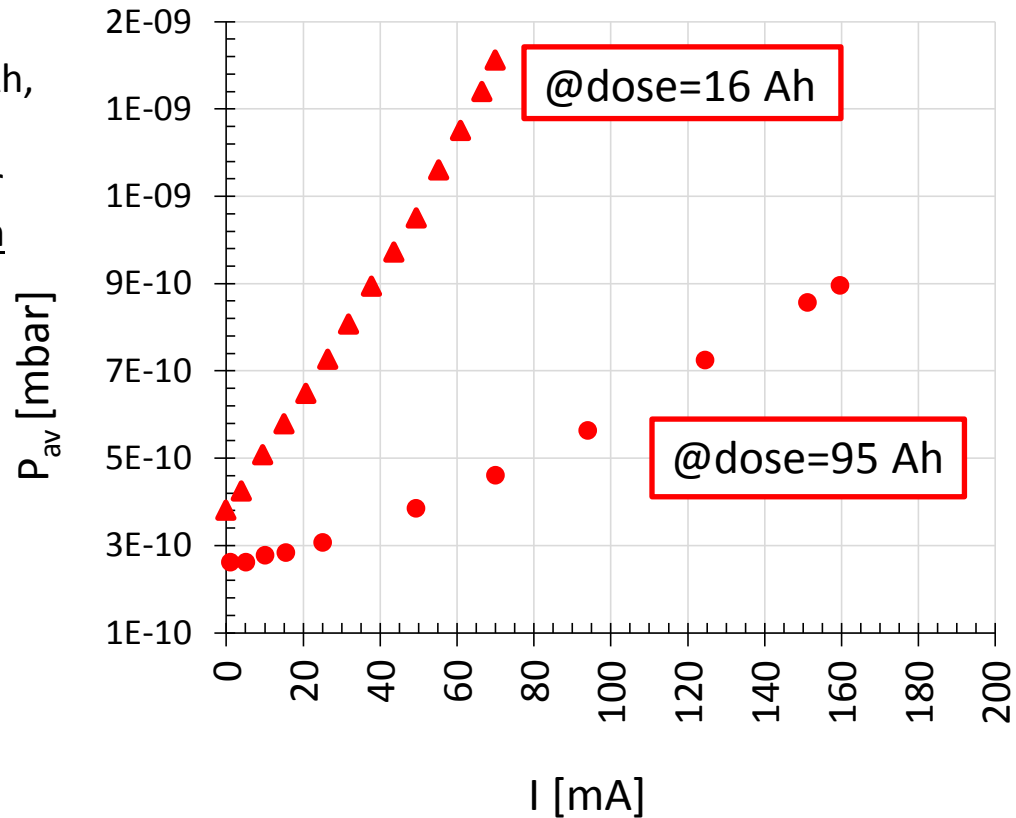
Pressures at dose 16 Ah and 95 Ah, during beam ramp up. (pressure recorded by extractor gauge at not NEG coated crotch absorber in S1)

Pressure in one achromat vs beam current

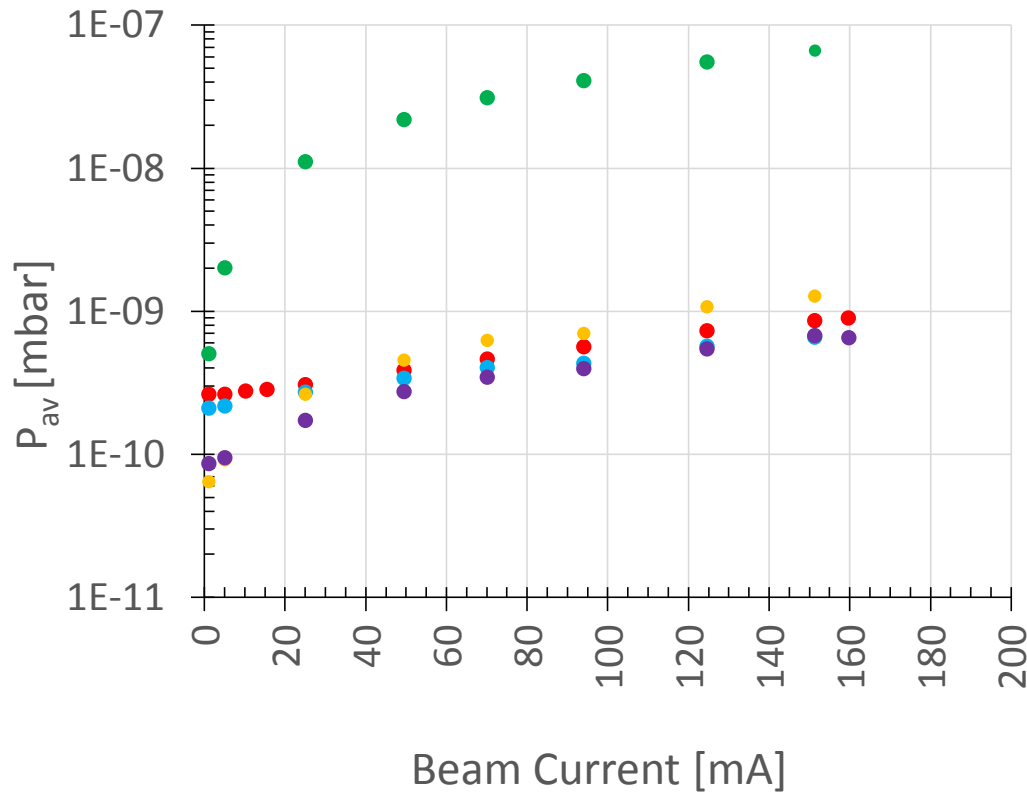
Pressures at dose 95 Ah, during beam ramp up, recorded at different positions along achromat (L, S1, S2)

- Pressure at S1 (ion pump)*
- Pressure at S1 (extractor gauge)
- Pressure at S2 (penning gauge)
- Pressure at S2 (ion pump)
- Pressure at L (ion pump)

* Pressure at S1 (ion pump) probably due to electrical effect

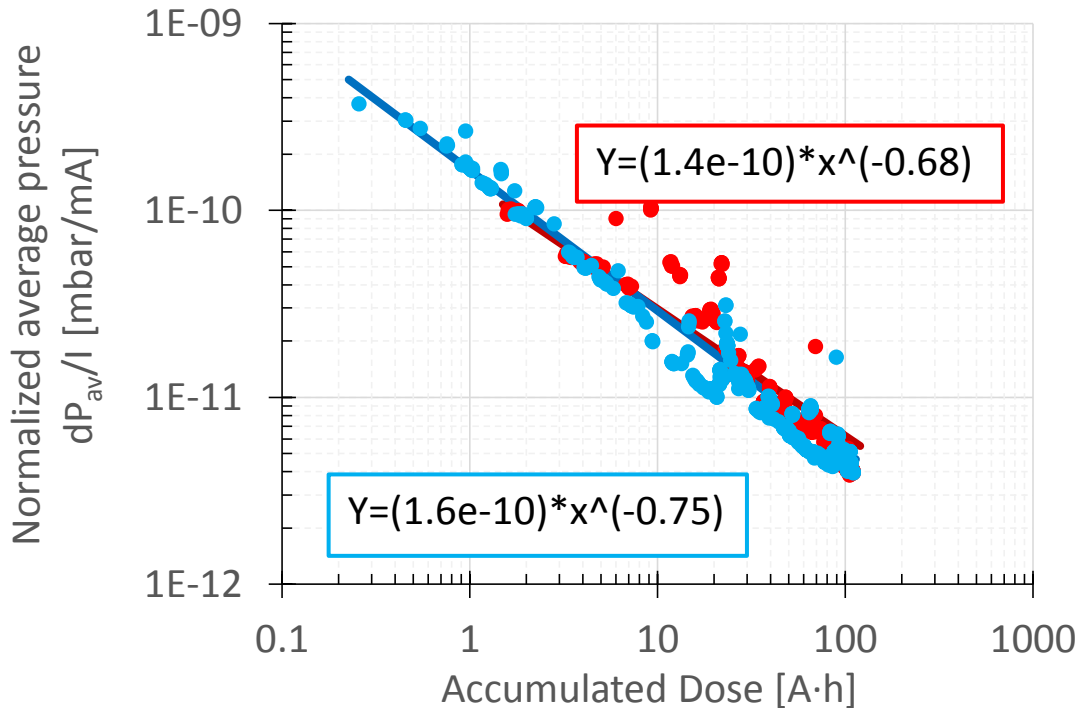
Normalized average pressure vs beam dose, recorded in S1 uncoated crotch absorber, and S2 NEG-coated

- Pressure at S1 (extractor gauge)
- Pressure at S2 (penning gauge)

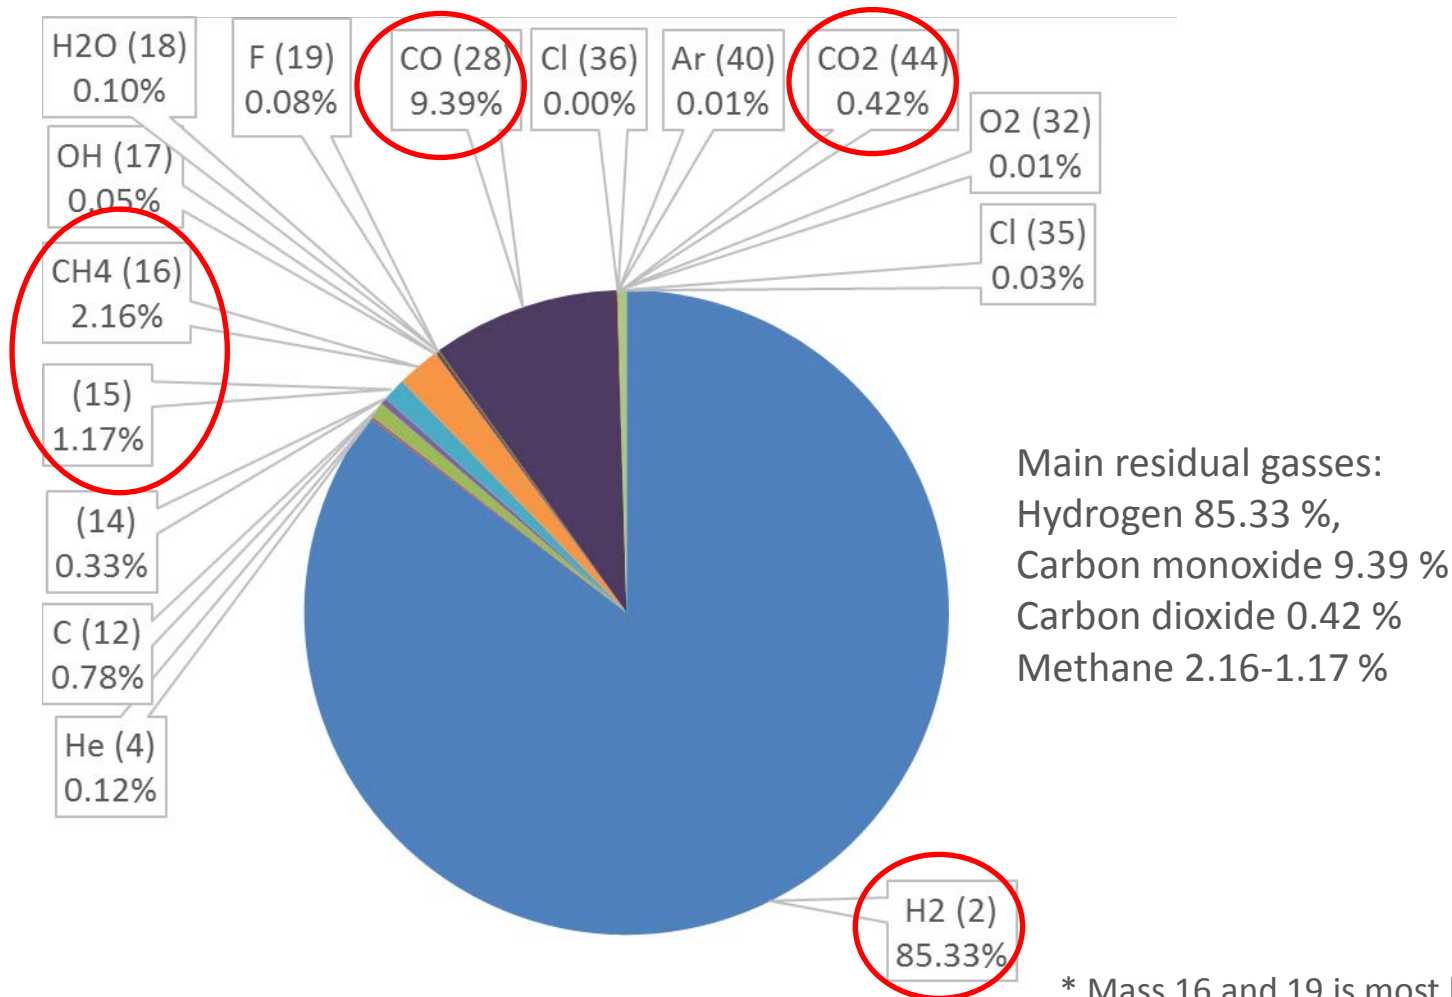
Residual gas spectrum at 140 mA beam current

* Mass 16 and 19 is most likely due to intrinsic degassing of the gas spectrometer.

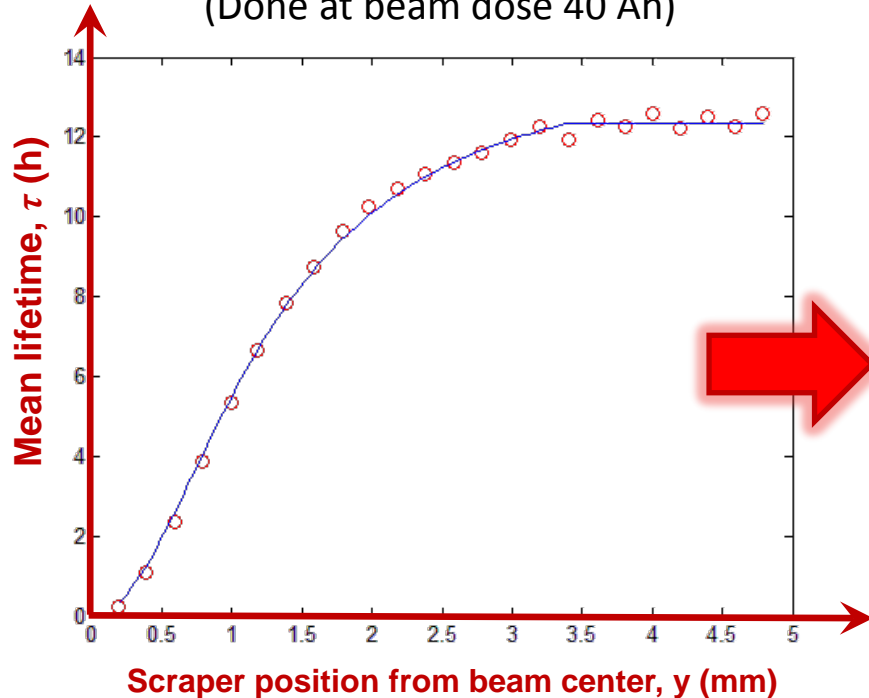
Mean lifetime vs vertical scraper distance from the beam center
(Done at beam dose 40 Ah)
